## PROPERTY CONDITION REPORT

### Whole Dogz

Subject: Property Condition Report  
Whole Dogz  
4748 Eisenhower Avenue  
Alexandria, Virginia 22304  
Partner Project No. 23-400799.1

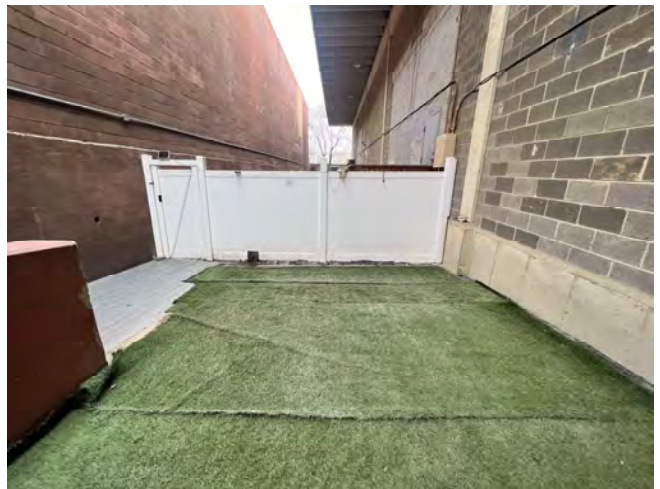
Replacement of the synthetic turf flooring is anticipated throughout the evaluation period. An opinion of cost for this work is included in Table 2.

6. Exterior play area

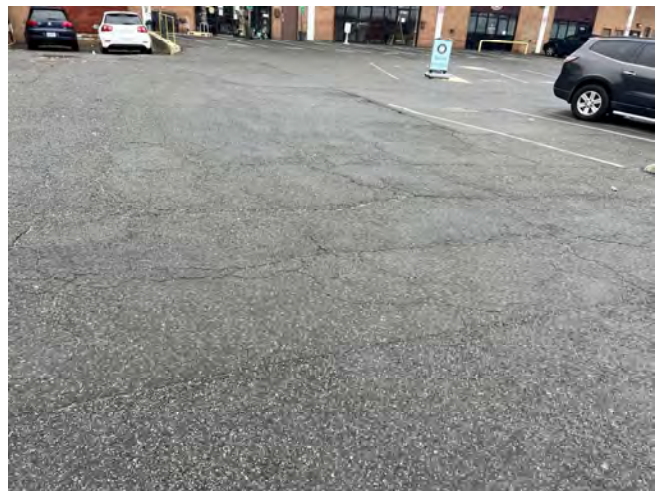
Asphalt pavement appeared to be in good to fair condition. Damaged pavement consisting of alligator and linear cracking were observed in the parking lot area. Sectional full-depth replacement and crack routing/sealing is recommended. An opinion of cost for this work is included in Table 1.

10. Cracking in asphalt pavement

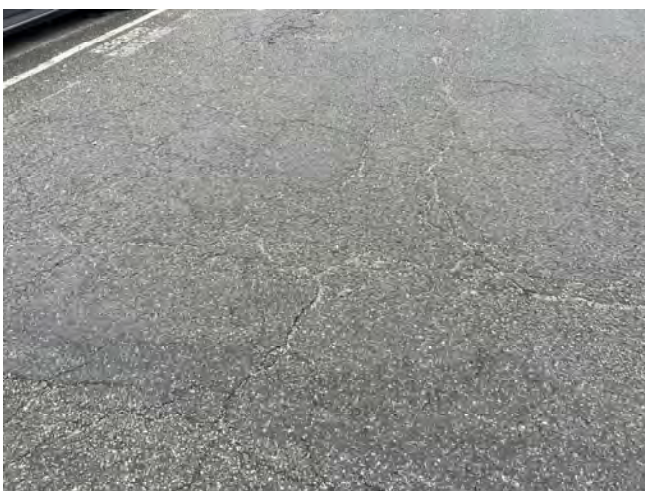
11. Cracking in asphalt pavement

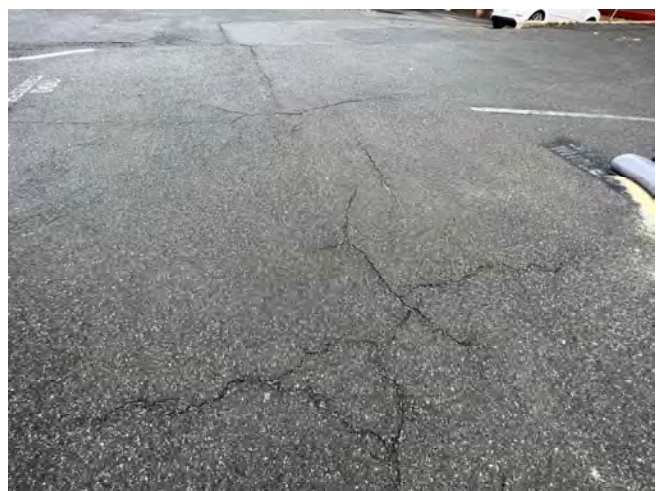
12. Cracking in asphalt pavement

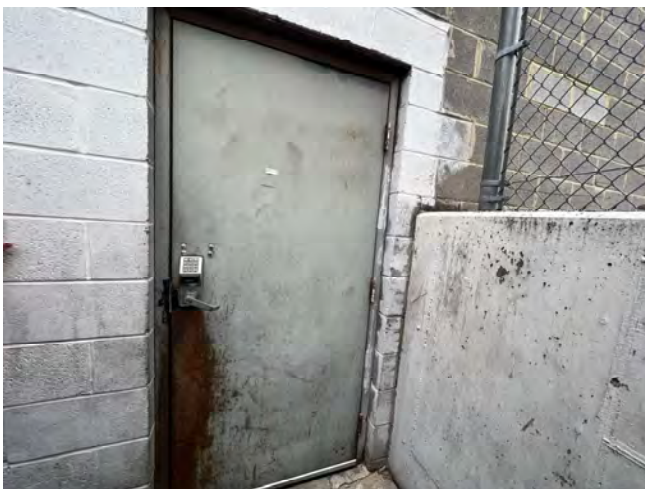
Doors were reported and appeared to be in good to fair overall condition. Some corrosion was observed on secondary doors. Cleaning, repainting, or replacement can occur as part of routine maintenance. Routine maintenance is anticipated throughout the evaluation period.

17. Exterior of exterior door

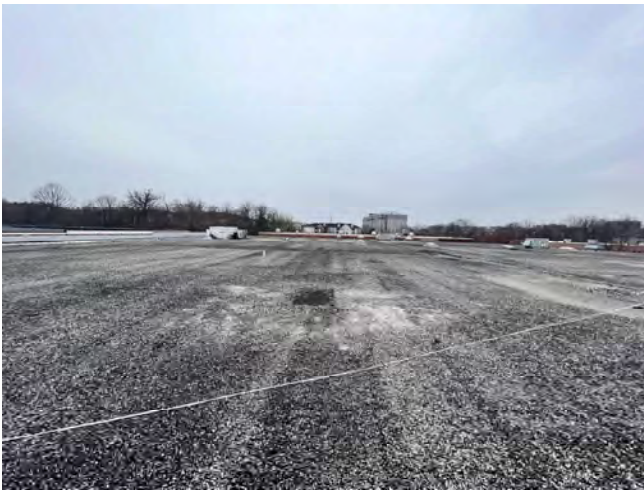
The roofing system appeared to be in good to fair overall condition. The roof installation date was not reported. No roof warranty information was provided. Based on visual observations and aerial imagery, the roof appeared to be approximately 15 years old. Based on EUL, replacement of the built-up roof is anticipated during the evaluation period. An opinion of cost for this work is included in Table 2.

21. Built-up roof topped with pea gravel

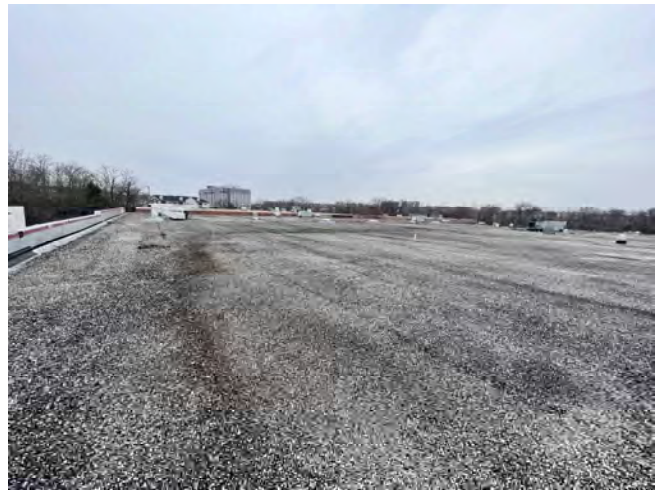
22. Built-up roof topped with pea gravel

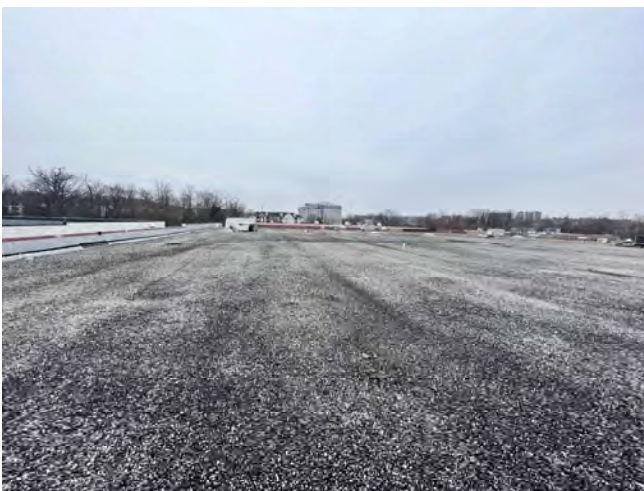
23. Built-up roof topped with pea gravel
