Duke Street Transitway

Existing Conditions Report

The City of Alexandria

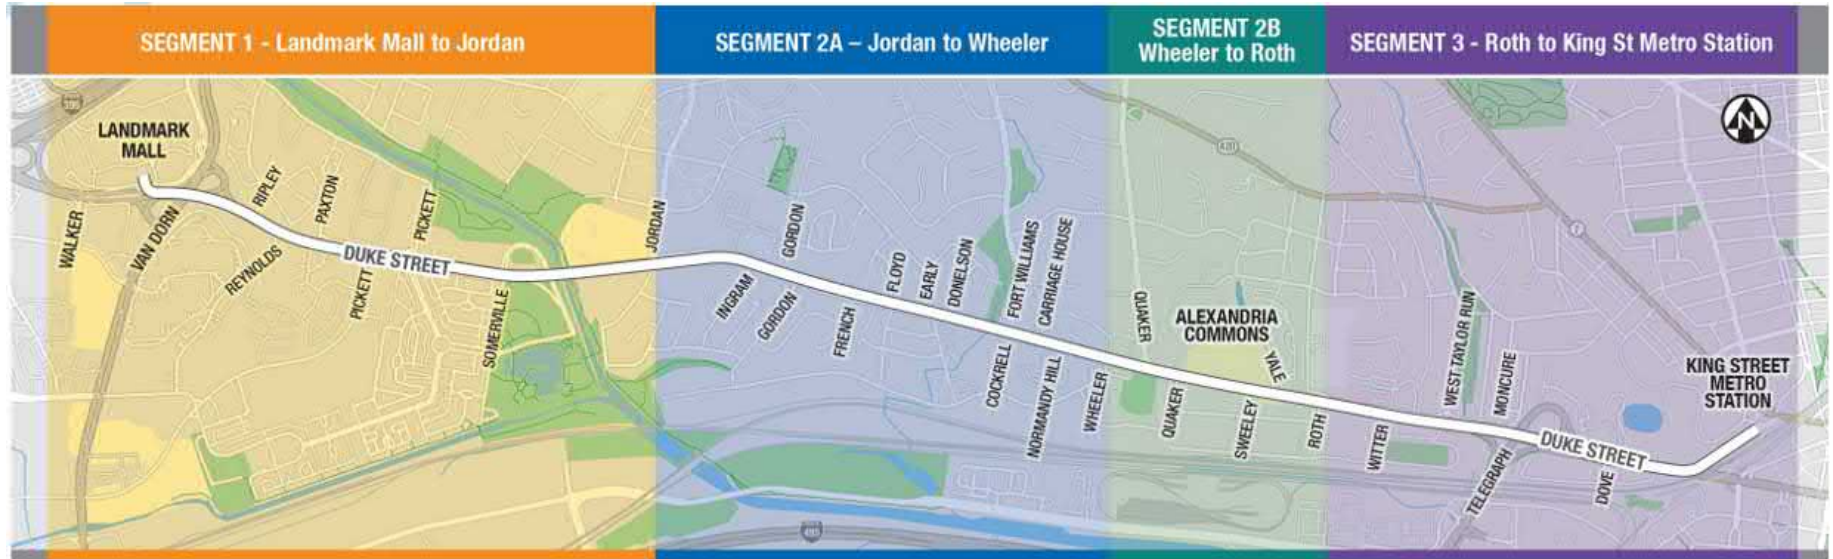
Figure 1: Duke Street Corridor Segments

The corridor is divided into four segments, referred to as Segment 1, Segment 2A, Segment 2B, and Segment 3 (see **Figure 1**). The termini of the segments are as follows:

- Segment 1: Landmark Mall (future WestEnd – Alexandria) to Jordan Street
- Segment 2: Jordan Street to Wheeler Avenue
- Segment 2B: Wheeler Avenue to Roth Street
- Segment 3: Roth Street to King Street Metro Station

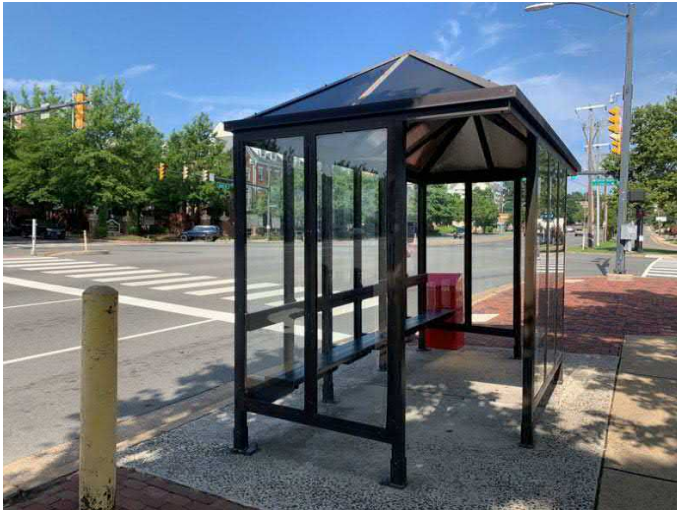
For reference, **Figure 15** and **Figure 16** below show examples of stops with all basic elements, with one stop also featuring a shelter and seating. These photos were obtained during field review.

Figure 15: Example of Stop with All Basic Elements, Seating, and Shelter (Photo Source: Toole Design)

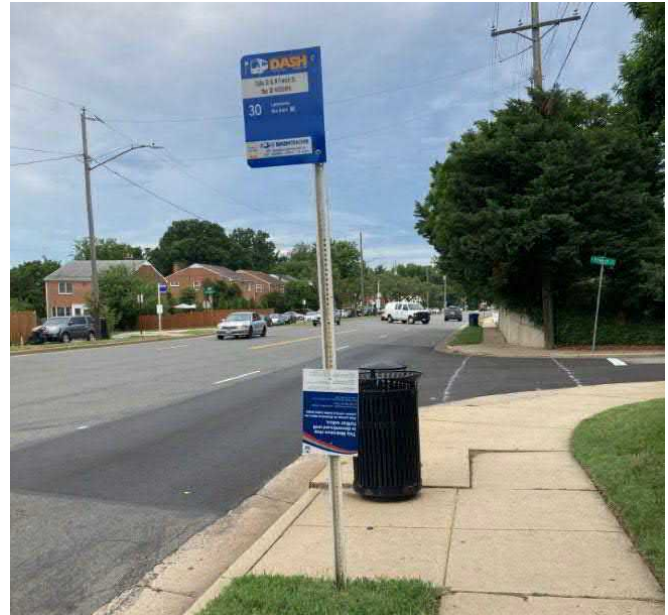
Figure 16: Example of Stop with All Basic Elements (Photo Source: Toole Design)

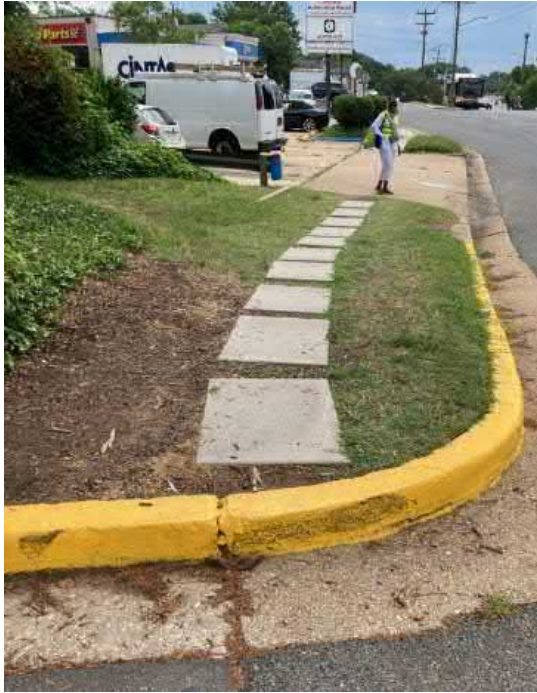
For reference, see **Figure 20** and **Figure 21** for examples of sidewalks rated as “Needs Improvement” and “Fair”, respectively, that were observed during the field review.

Figure 20: Example of Sidewalk Near Foxchase Apartments Rated as “Needs Improvement” (Photo Source: Toole Design)

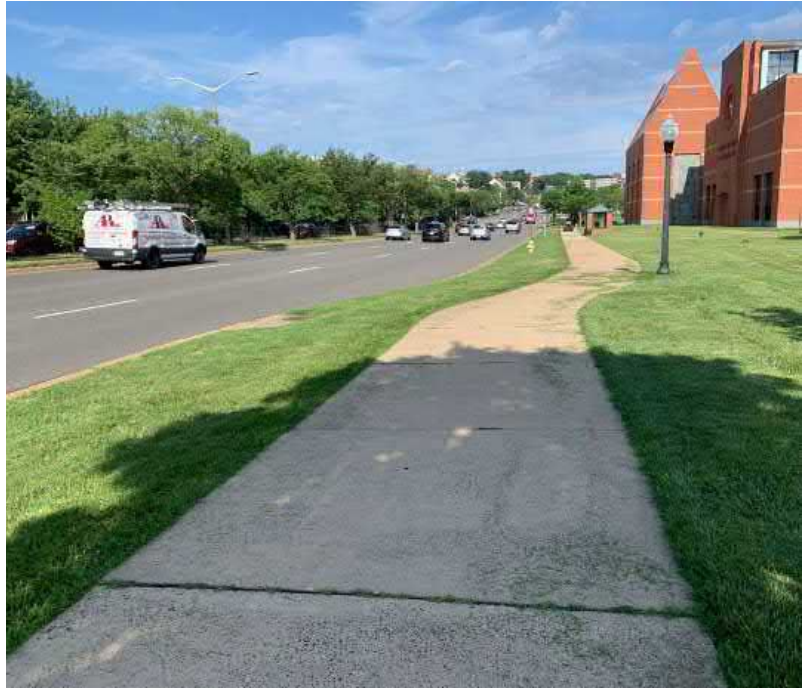
Figure 21: Example of Sidewalk Near the Library Rated as “Fair” (Photo Source: Toole Design)
